GET ACTIVE WASHOE

Physical Activity Engagement
and the Built Environment
Assessment

WALKING AUDIT

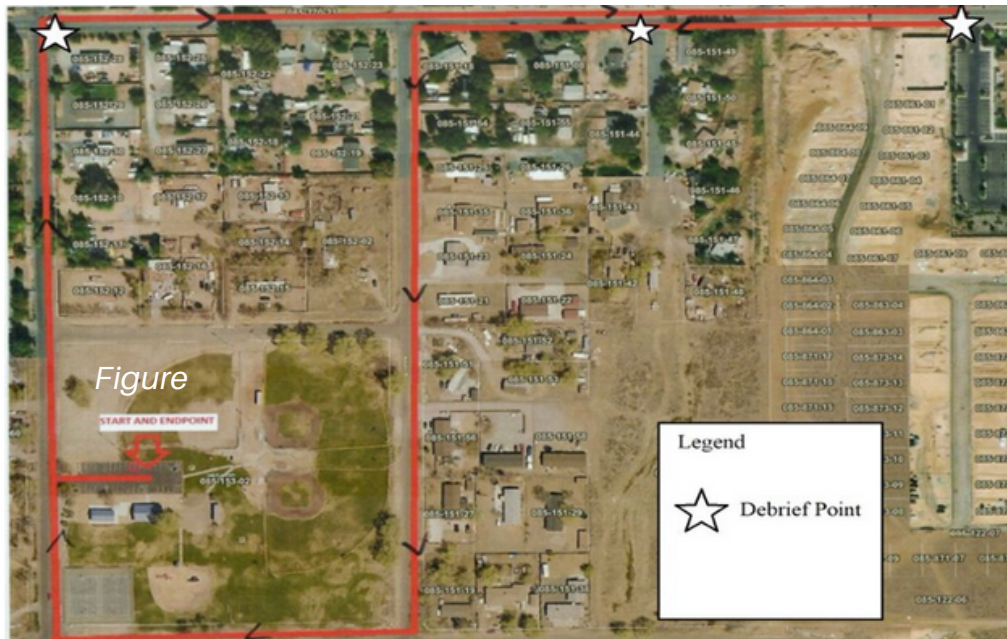
Figure 1: Walk audit route covering 4th Avenue, Gepford, Leon Drive, and Woods Drive. Planned for 08/08/23. (Source Washoe GIS)

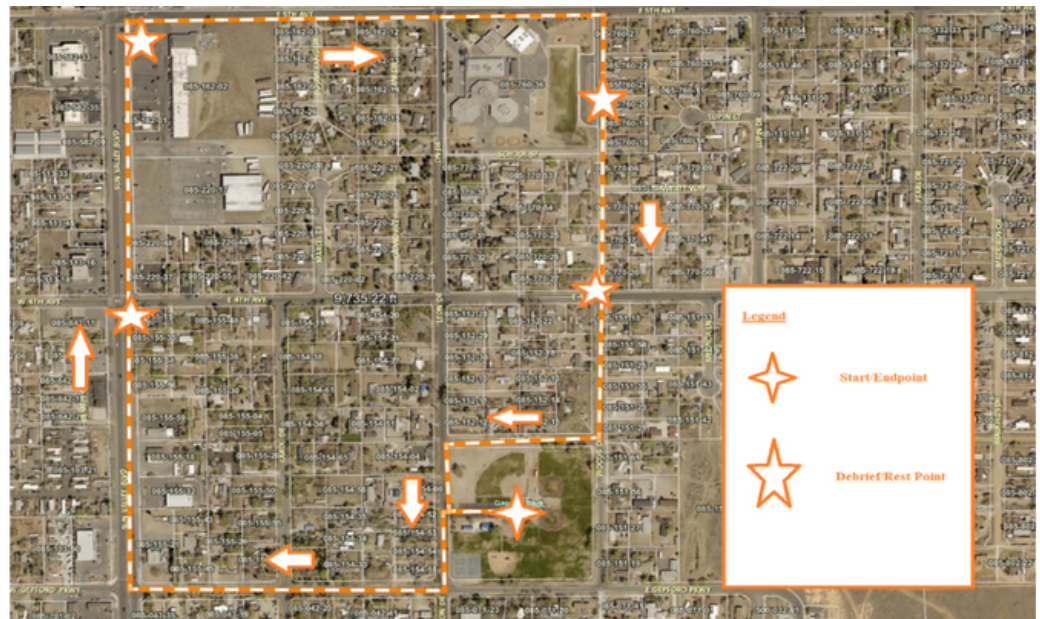
Figure 2: Walk audit route covering Gepford, Sun Valley Blvd, 5th street, and Woods Drive. Planned for 08/12/23. (Source Washoe GIS)

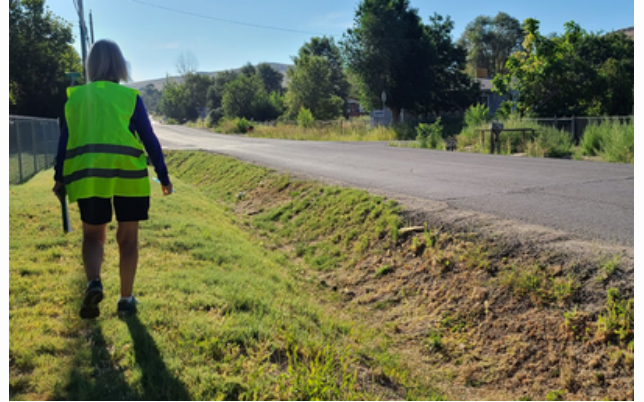
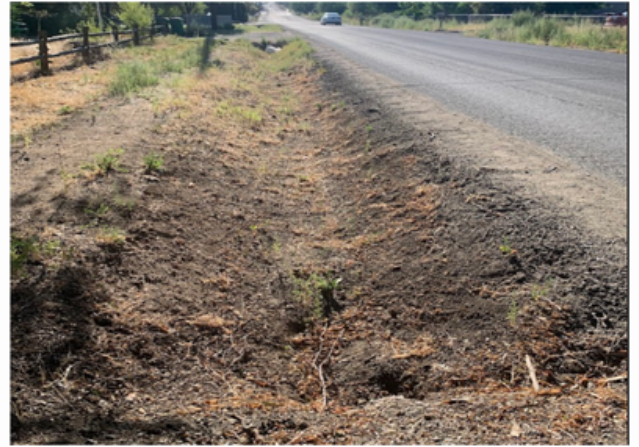
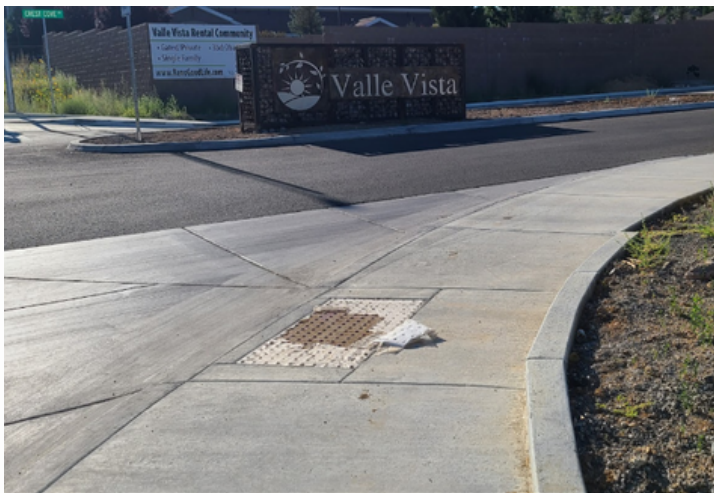
The walk audits revealed several issues with the Sun Valley area regarding pedestrian safety measures. On the first walk audit which focused on residential roads, the walk experience along the walk route was uncomfortable and unsafe at multiple points. The entirety of the route was characterized by the lack of proper paved sidewalks. Instead, common walk paths were often dirt or gravel by nature, often being covered by overgrown vegetation or being somewhat obstructed by trash. Separating the walk path from the road were open drainage culvert or ditches. These open ditches would make the walk path narrower and present a potential hazard for passing cars to potentially drive into and get stuck in.

The most immediate recommendation is to pave over open drainage ditches with a proper sidewalk with a gutter system. Have a walking path that is up to code and ADA compliant. Create enough buffer room for bikers and pedestrians alike.

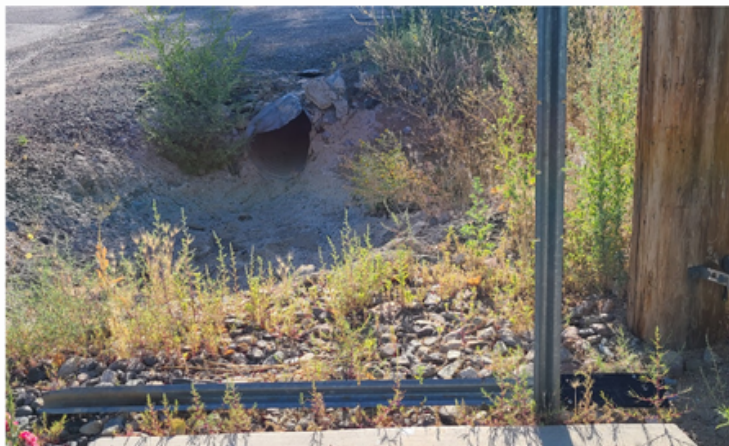
At all intersections, there were no ADA compliant ramps to help pedestrians get onto the curb after crossing the street. The only section of 4th Avenue with proper paved sidewalks built to modern code was near the Church of Jesus Christ of Latter Days Saints and a new development of rental homes. Once cleared of this specific area, the sidewalks returned to being unsafe and uncomfortable. In fact, the end of the sidewalk once past the church is punctuated by a deep drop into a culvert that is only obstructed by metal poles sticking out of the ground with no visible signage to warn pedestrians of a serious hazard ahead.

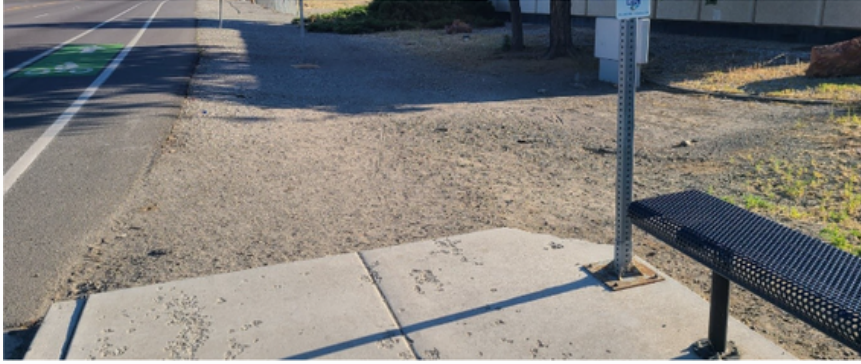
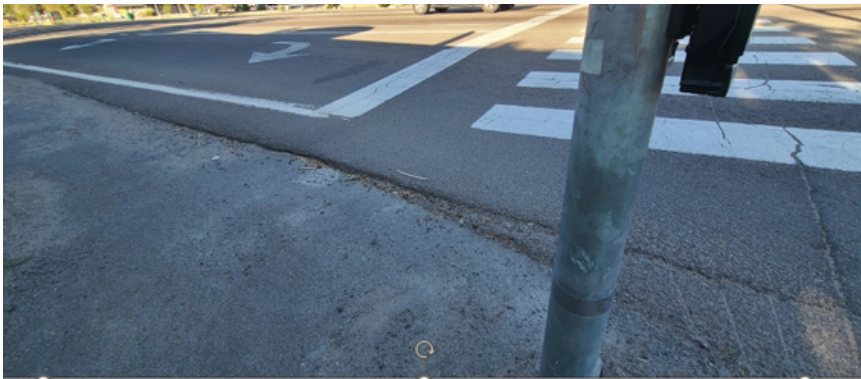
Once onto the main Sun Valley road, there were interrupted sections of paved crosswalks that only lead to bus stops. However, the same issues that plagued the residential roads can be found on Sun Valley Blvd where there were only gravel paths blocked and interrupted by rocks and trash. Walk paths into business plazas were consistently interrupted by ADA noncompliant features such as rocky ramps that lead onto asphalt walk paths. Street lighting was also found to be intermittent as well, only being the most common along sides of the road with more businesses in the plaza. Bike lanes were found to be present on Sun Valley Blvd and were properly marked. However, drivers would sometimes cross into these bike lanes and come close to a standoff lane reserved for pedestrians or emergency parking. Turn lanes were too close to the “curb” as well, making it potentially easier for cars to hit pedestrians when making right-hand turns without paying attention.

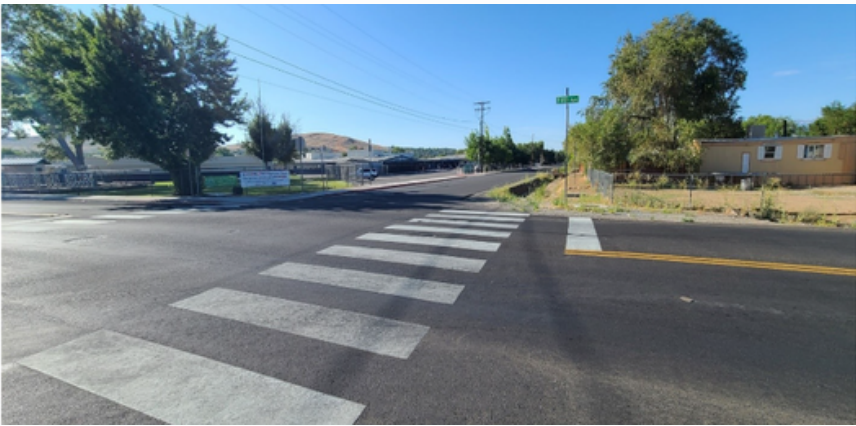
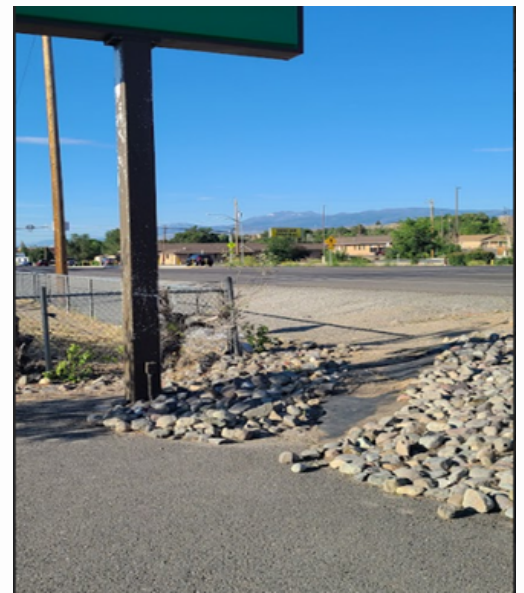
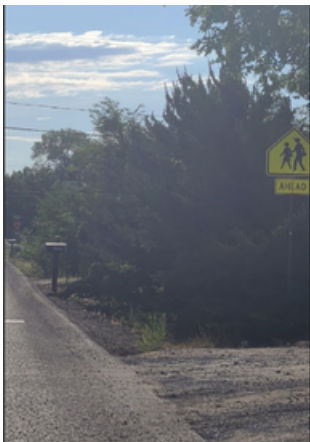
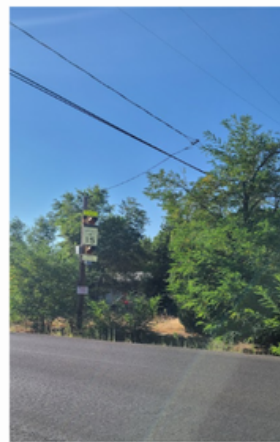
The only section of properly paved sidewalks with ADA compliant ramps was on 5th Avenue near the school zone. Despite this proper application of modern construction code, road signs such as school zone indicators and speed limit signs were obstructed by overhanging trees.

Landscaping efforts to maintain overgrown foliage for adequate visibility of roadways, pedestrians, and signage.

For crosswalks and stop lines, the markings on the road are heavily faded and need to be repainted. Additional speed limit signs would be helpful on long stretches of road. Installing more residential streetlights would be advisable.
